Manhole Inspection Summary

Manhole # S17AA_024MH

Insp Date: **10/31/07 9:25 AM**

Location Address: **2320 CHIEF ST**

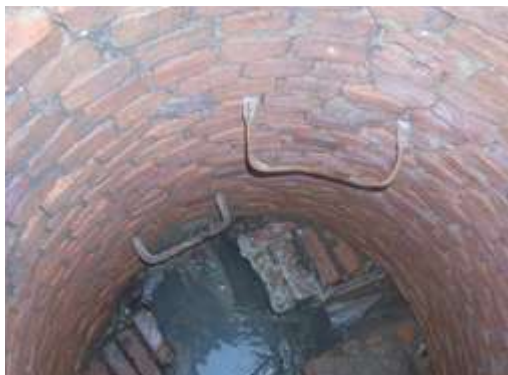
Defect 6

Count: **2** Missing: **0** ☒ **Corroded**

CORRODED STEPS

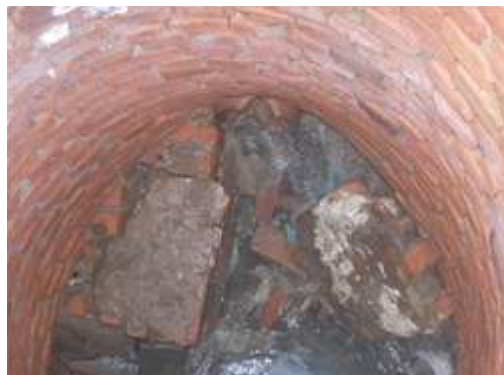
Defect 5

Condition: ☐ Sound ☐ Cracked ☐ Root Intrusion ☒ **Deteriorated** ☐ Leaks ☒ **Debris**

BENCH DETERIORATION CAUSING
CHANNEL BLOCKAGE

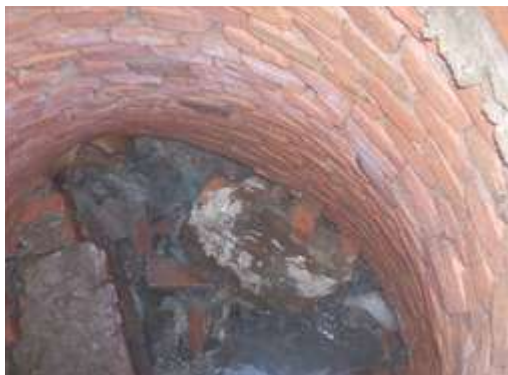
Defect 4

Condition: ☐ Sound ☐ Cracked ☐ Root Intrusion ☒ **Deteriorated** ☐ Leaks ☐ Debris

EXTREME BENCH DETERIORATION

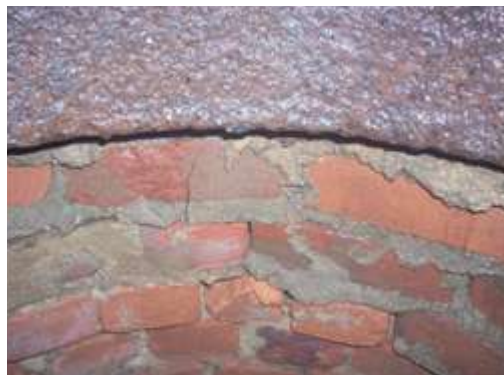
Defect 2

Condition: ☐ Sound ☒ **Cracked** ☐ Root Intrusion ☐ Loose Brick ☒ **Deteriorated**

DETERIORATED CHIMNEY

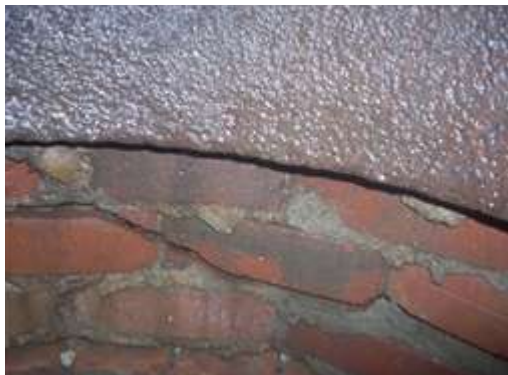
Defect 1

CRACKED CHIMNEY

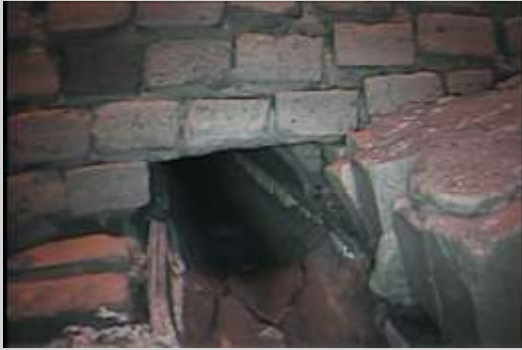
6 O'Clock Inflow

Infiltration: **None** Pipe Seal Cond: **Broken**

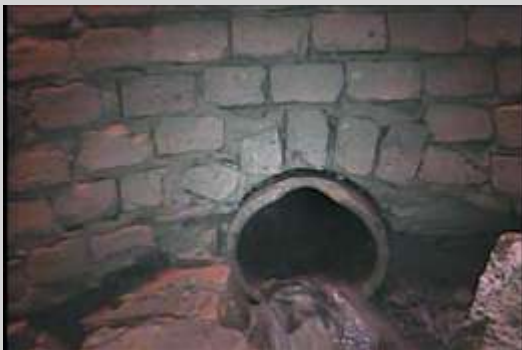
9 O'Clock Inflow

Infiltration: **None** Pipe Seal Cond: **Broken**
